WASHINGTON STATE HISTORIC COUNTY COURTHOUSE ASSESSMENT

PREPARED FOR THE WASHINGTON STATE OFFICE OF
ARCHAEOLOGY AND HISTORIC PRESERVATION

JUNE 2003

Washington State Historic County Courthouse Assessment

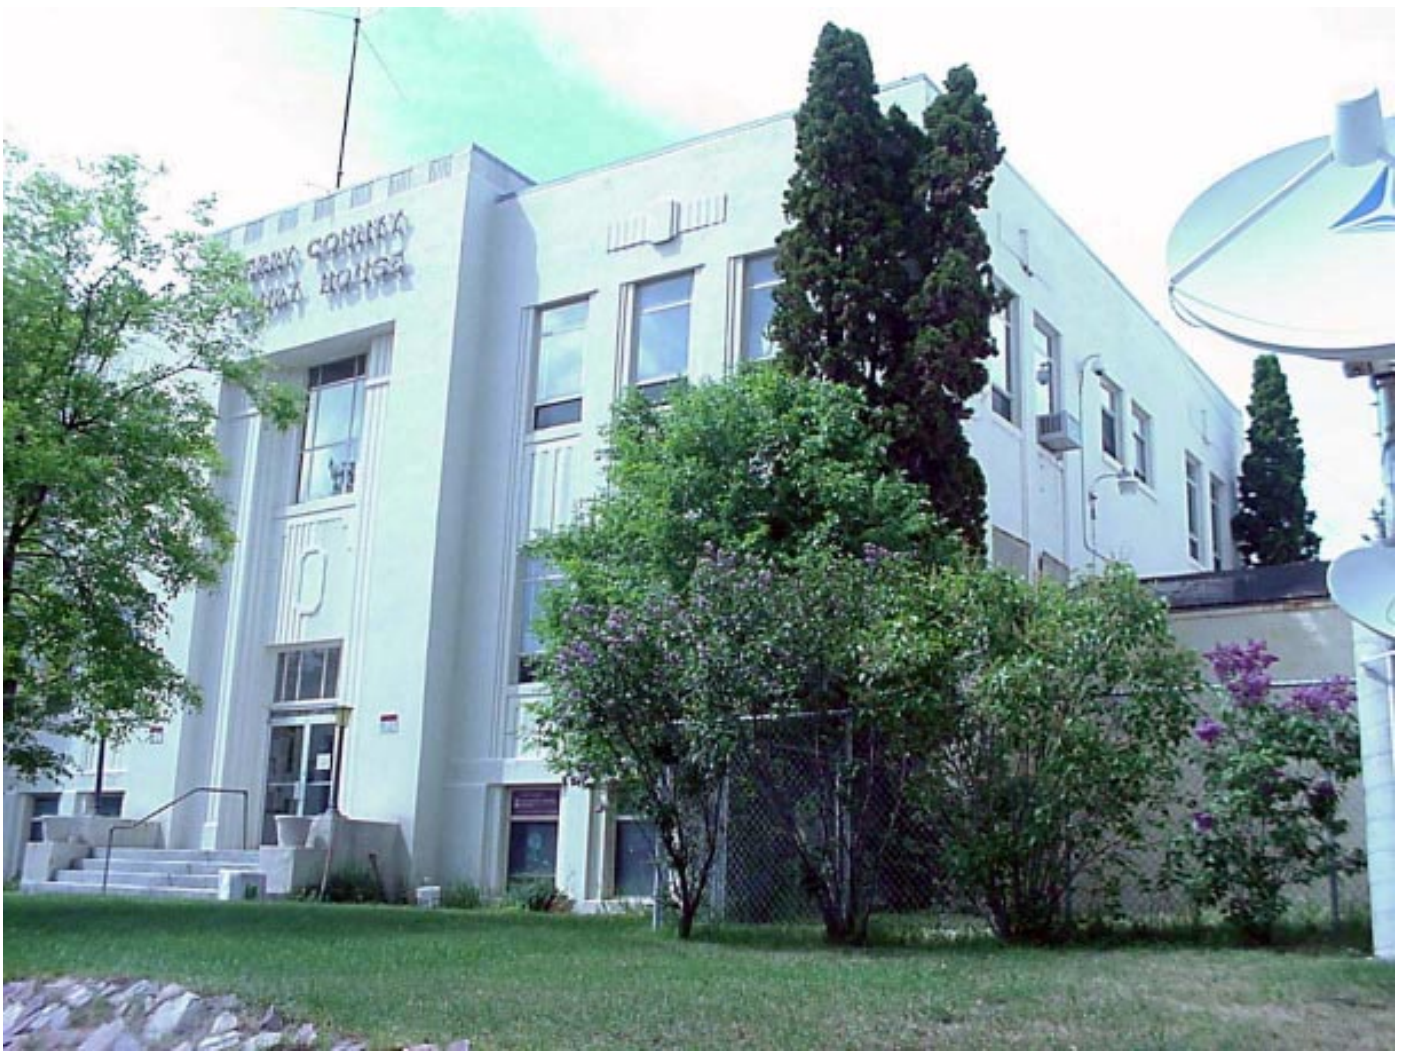
PRIMARY FACADE.

Re-roofing 40K. Boiler and retrofit radiators 70K. Clean and repaint exterior 25K. Lighting fixture retrofit 20K. Interior rehabilitation 280K.

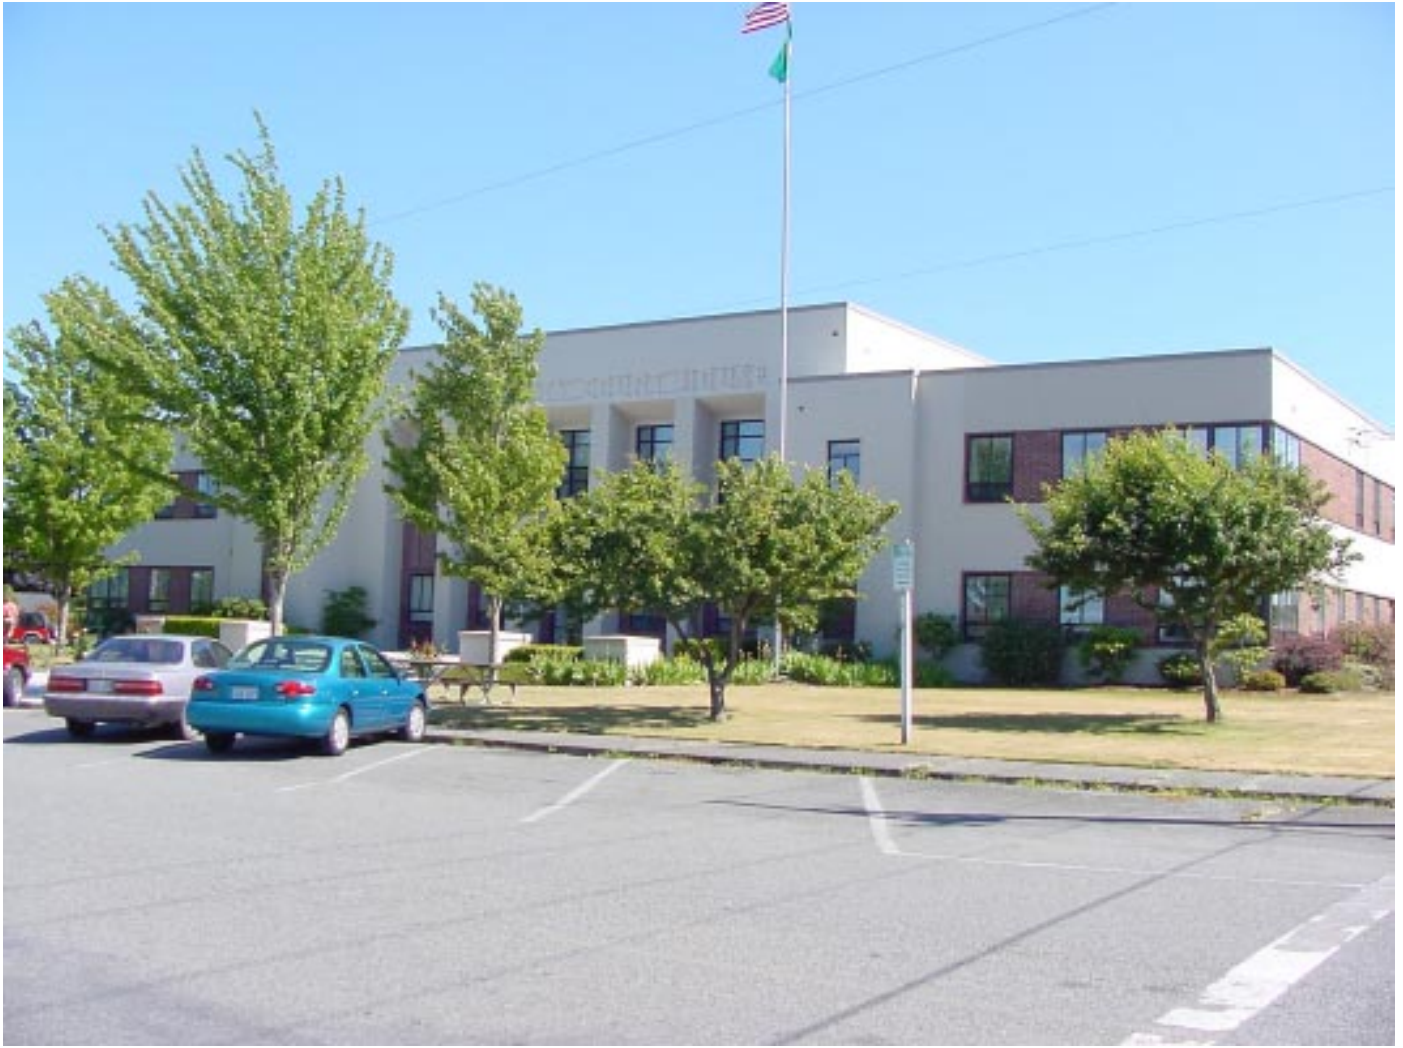
2001 built new courthouse. 2002--added 8" of width to interior wall and steel stiffening during seismic retrofit. Remodeled office space. All new mechanical, electrical, HVAC. No exterior work (stucco crack).

PRIMARY FACADE.

Exterior rehabilitation. Brick damage. Stucco and brick rehab. Repaint.

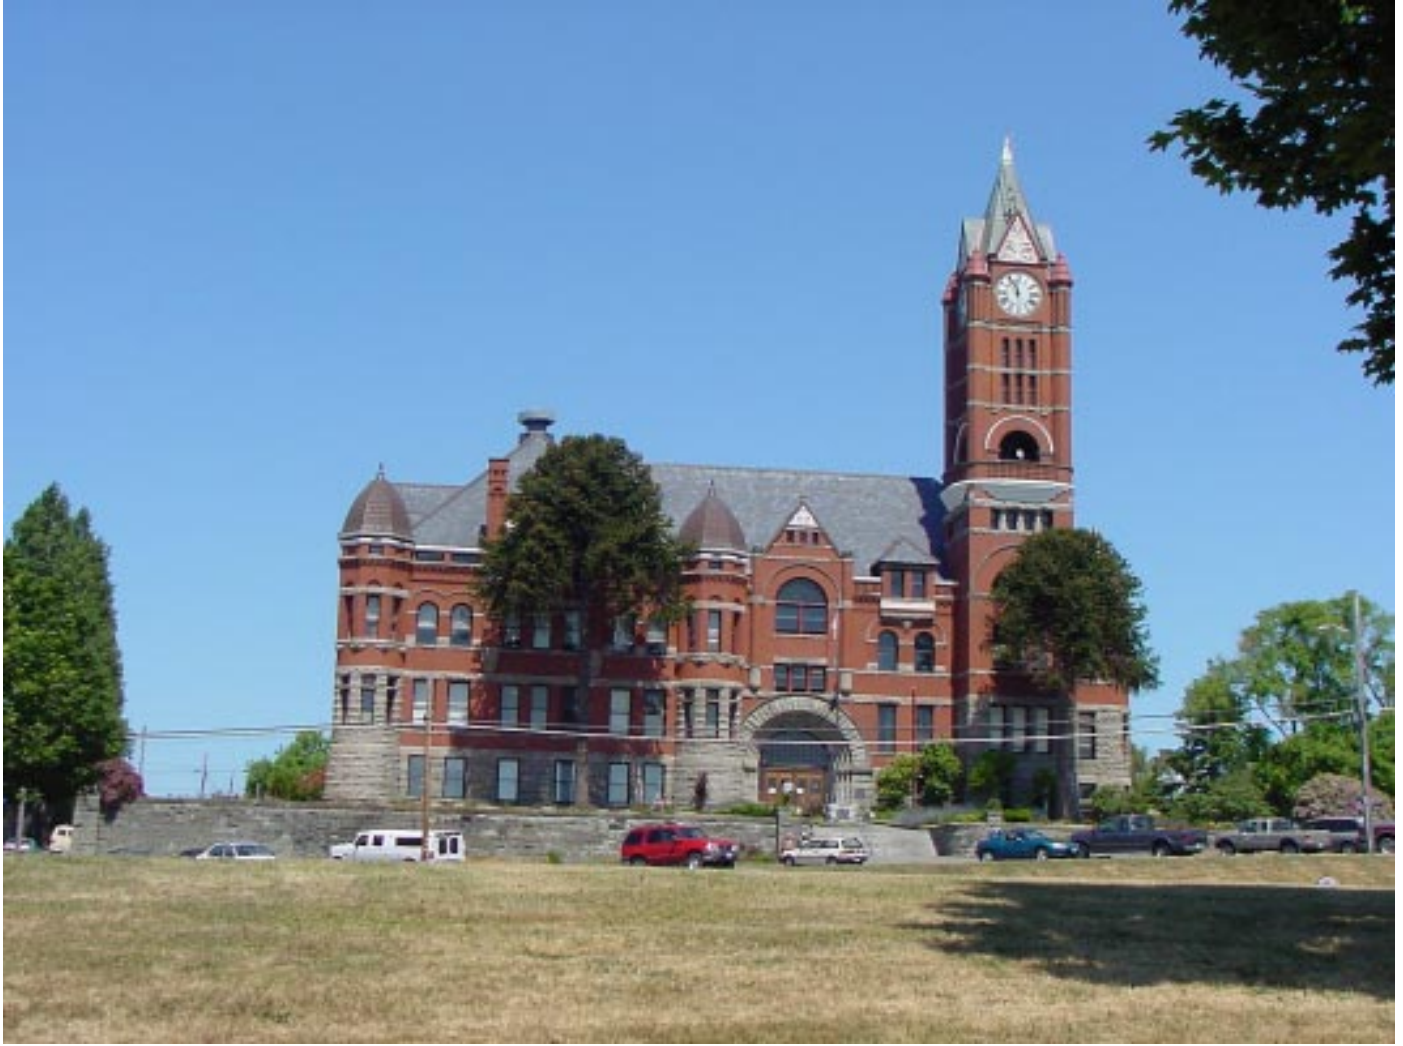
Construction Type: Unreinforced steam pressed brick masonry with Alaskan sandstone foundation. Interior masonry walls with plaster finish. Romanesque style.

Reasonable condition for age. Needs restoration. Much of what was original remains intact, very little historic fabric has been impacted.

PRIMARY FACADE.

EQ structural retrofit on clock tower (\$4 million). Courthouse upgrade, including seismic (base isolation), mechanical, electrical, plumbing, communications, exterior envelope including entries, windows, brick and stone masonry (\$35 million). If cautious base isolator approach to seismic upgrade is excluded (25 million). Courthouse grounds, including site drainage, accessibility, sidewalks, parking, lighting, site security (\$1 million).

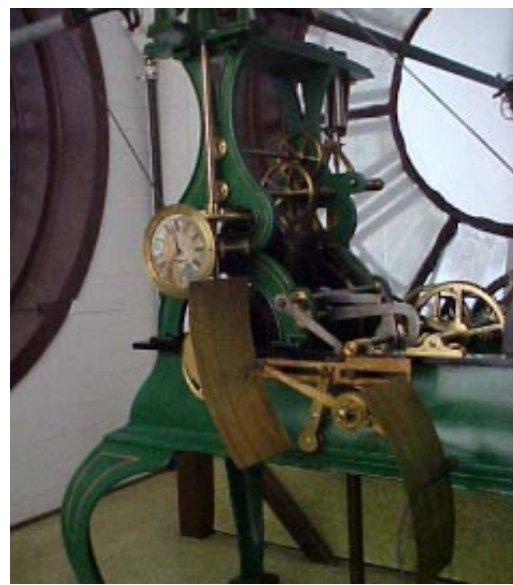
CLOCK MACHINERY.

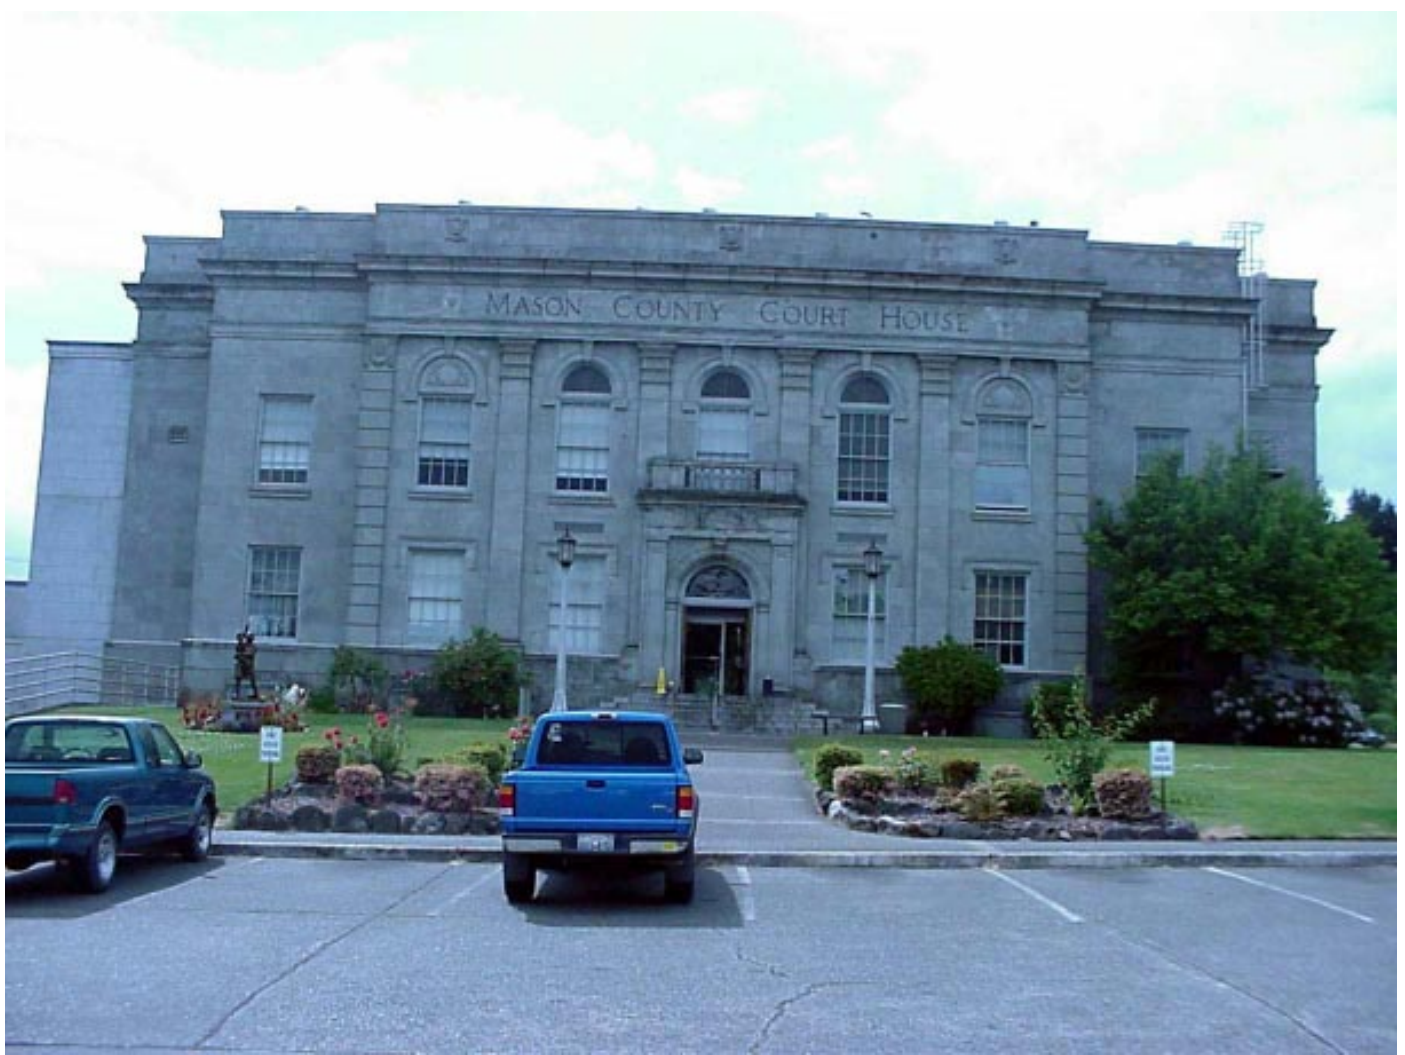
PRIMARY FACADE.

Spalling exterior stone restoration/needs cleaning. Interior rehabilitation, including HVAC, plumbing, electrical, courtroom remodeling. Would like to reinstall historic doors and repair or replace historic windows. Tried for a bond issue of \$3.5 million for courthouse rehab a few years ago which didn't pass.

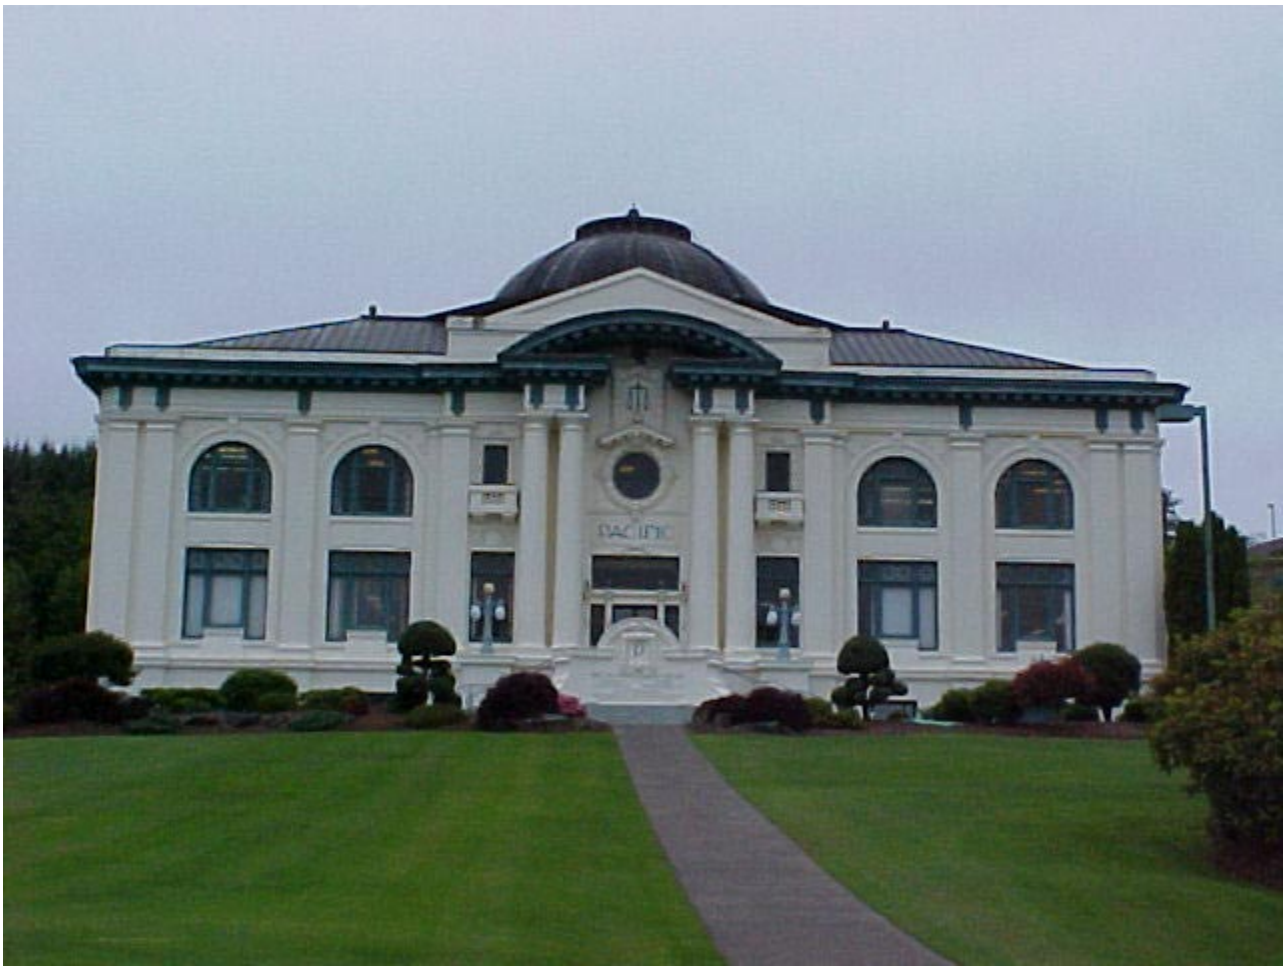
Paid for with bond. Seismic upgrade (reinforced roof/wall). Copper roof (leaking). Exterior; stripped, painted. Sealing of basement. 1980 -- \$150,000 releaded all stained glass.

PRIMARY FACADE.

Not energy efficient, HVAC inefficient. Remodeling basement. Windows could be rebuilt. Roof repair. Study by Caldwell Thomas. Re-create Rotunda balustrade. Basement and window repair and retrofit 100K.

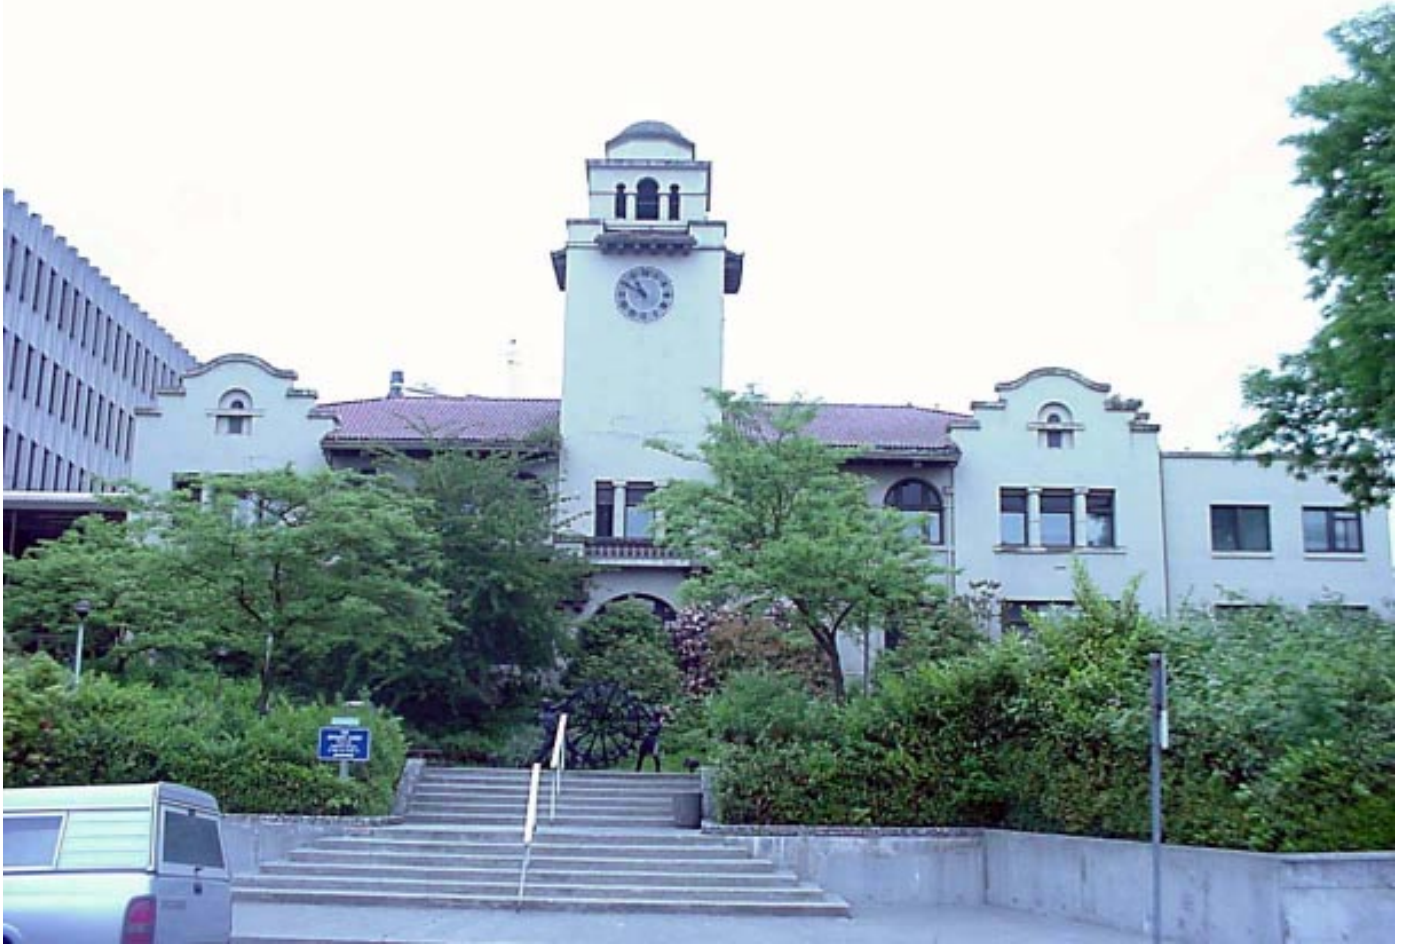
Built in 1897, burned in 1909, rebuilt in 1911. Needs a lot of work. Stucco cracked at clocktower -- earthquake damage. Windows are original with some metal sash. Main historical entry closed and new addition to north circa 1970. Formal interior entry gone.

PRIMARY FACADE.

Roof first. Asbestos abatement in crawl space - very difficult project. HVAC. Electrical upgrade. Window replacement. Interior carpet. Painting/resealing. Seismic evaluation by engineering firm (Skilling, Word, Magnuson; contact: John Hooper) estimated at \$7.6 million. Capital facilities plan exists but has little money.

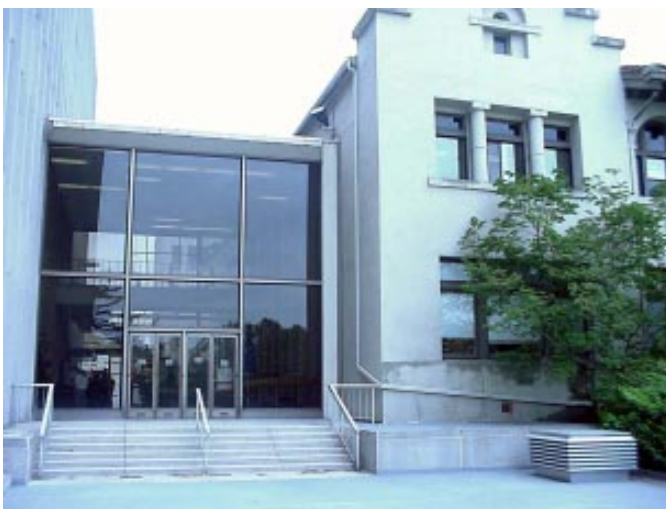
DETAIL OF CONNECTION BETWEEN HISTORIC AND NEW ADDITION.

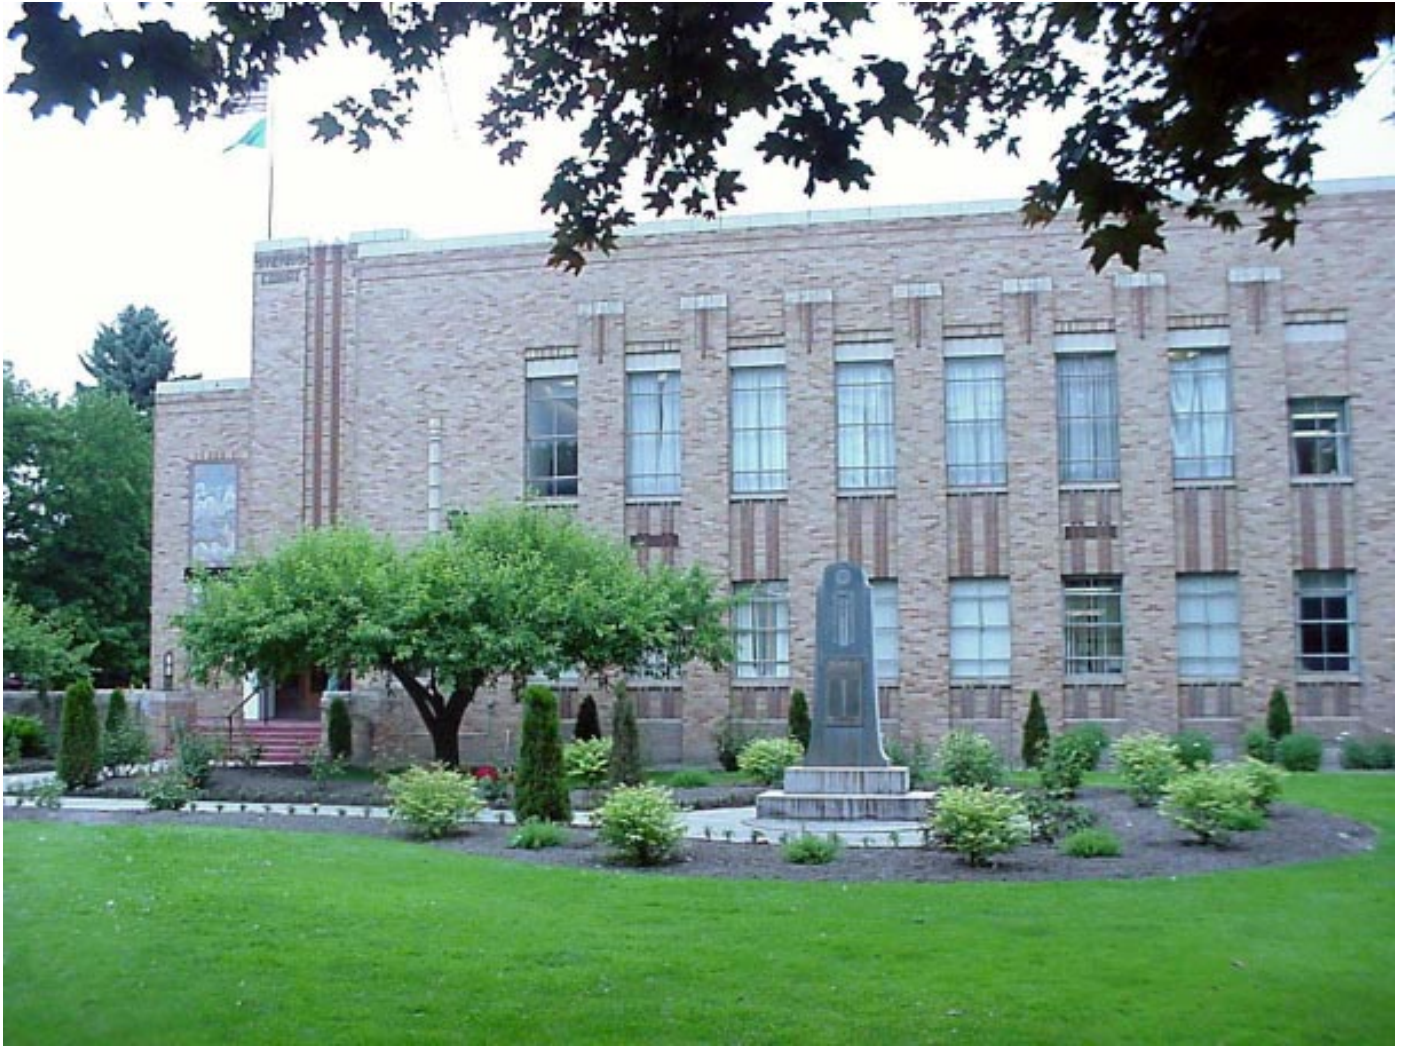
Excellent condition. Small addition on rear and large criminal justice facility on rear side. Original metal windows. Mahogany woodwork/doors.

PRIMARY FACADE.

Reroof \$75,000. Masonry cleaning \$65,000. Rehab metal windows \$125,000. HVAC \$250,000.
