INACTIVE AND ABANDONED MINE LANDS— Boundary Red Mountain Mine, Mt. Baker Mining District, Whatcom County, Washington

WASHINGTON
DIVISION OF GEOLOGY
AND EARTH RESOURCES
Information Circular 99
April 2005

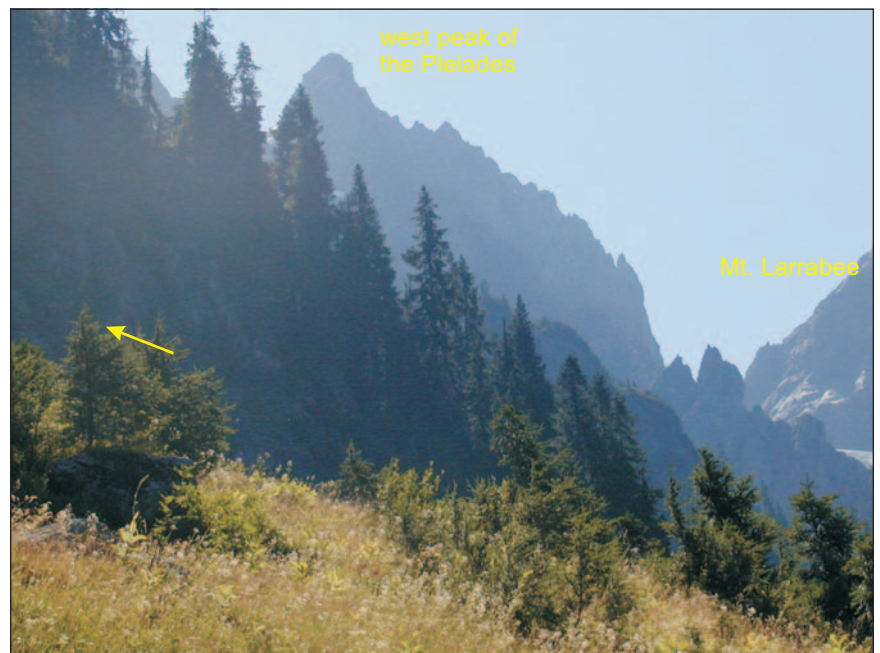
Figure 5. View to the southwest from the 500 Level landing. Arrow points to a trail leading to 100 and 200 Level portals.

entrance appears to be on a bench in a cliff face. Grant (1989) reported the 100 level caved near the entrance, but “Access has been gained via an open stope on the hillside ca. 100’ above the level. Overall though, its condition is badly deteriorated.” The

200 Level was caved 115 feet along the vein/adit intersection (Grant, 1987). Total development at the mine cannot be calculated precisely. The combined four main levels exceed 7000 feet in length. Sublevels, stopes, and raises drive the development figure upward to ~10,000 feet. Grant's report (1987) gives detailed explanations of stope development, assays along the vein, and widths. The highest grades encountered, approximately 1.13 ounces per ton gold over an approximate 3-foot mining width, were above the 500 Level. Moen's vertical cross section in Figure 2 is the best representation of the estimated development to date. Detailed maps also appear in Krom (1937).
