INACTIVE AND ABANDONED MINE LANDS— Boundary Red Mountain Mine, Mt. Baker Mining District, Whatcom County, Washington

WASHINGTON
DIVISION OF GEOLOGY
AND EARTH RESOURCES
Information Circular 99
April 2005

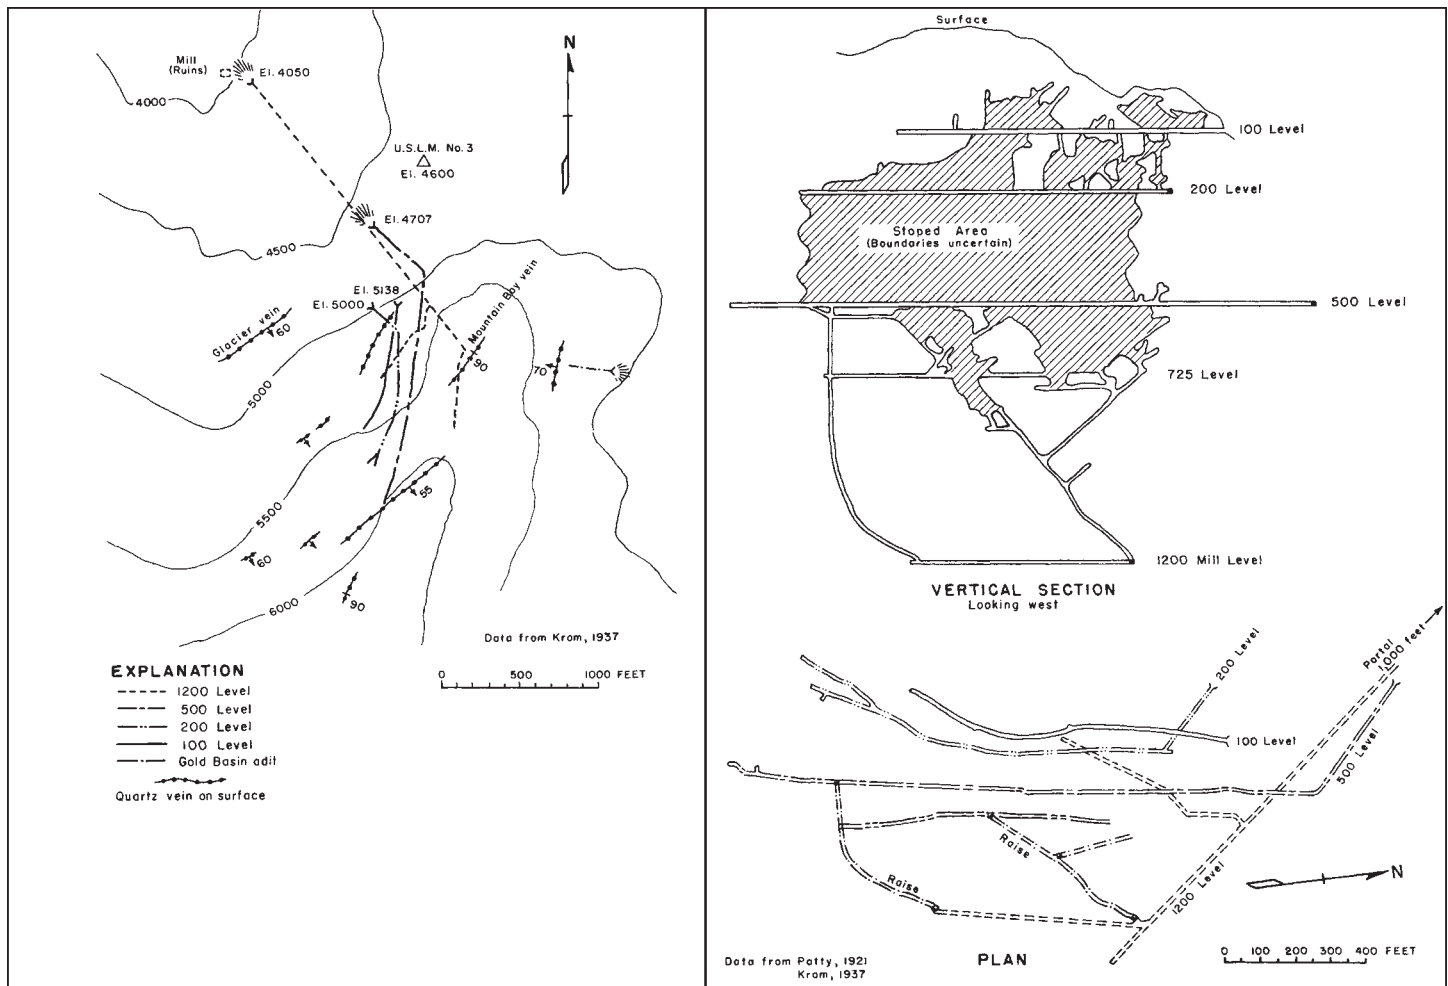
Figure 2. Site map of the Boundary Red Mountain mine workings and veins (after Moen, 1969).

The relationship of the veins to each other and to various levels is shown in Figure 2. The quartz fissure vein cropping out on the southeast skyline above the 500 Level portal is probably the Mountain Boy vein (Fig. 3) described by Krom (1937). It is at the approximate location of his point EE1 on plate 3 (DGER mine file). A short drift was driven on this outcrop and a 3-foot deep by 200-foot long trench extends to the east before disappearing in a cliff.

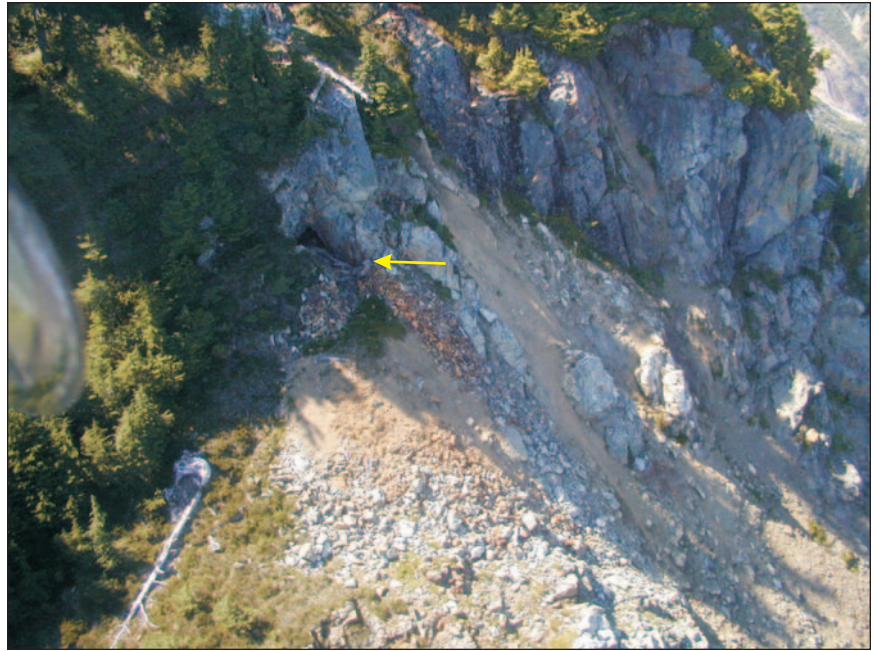
Figure 3. Outcrop and adit (arrow) of the Mountain Boy vein. View to the west.

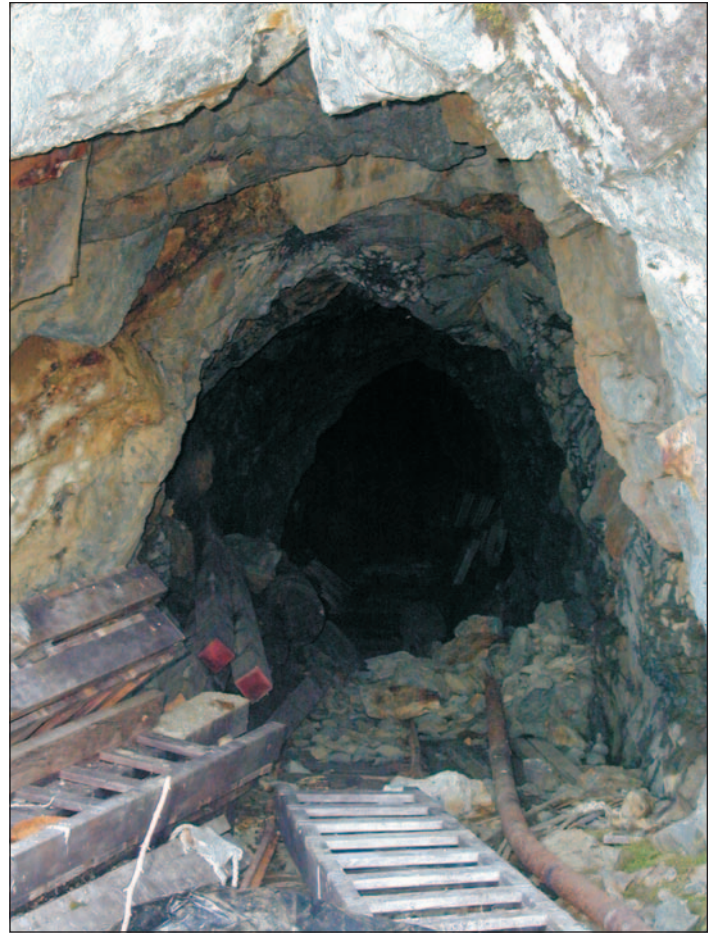
Figure 4. 500 Level portal with circa-1989 ladders and timbers.

The 500 Level portal is located on a relatively level bench. The aerial tramway used for lowering ore to the mill began at this point. The tram terminal foundation and a crushed tram bucket are still in place. The entrance is open, but shows sloughing a short distance inside. The overall condition is unknown as of September 2003; however, according to Grant, it was in good condition and open to the face 1987. A few replacement ladders and dimensional timbers are stored at the entrance (Fig. 4). A sparse trail proceeds uphill from this area to the 200 and 100 Level adits (Fig. 5).

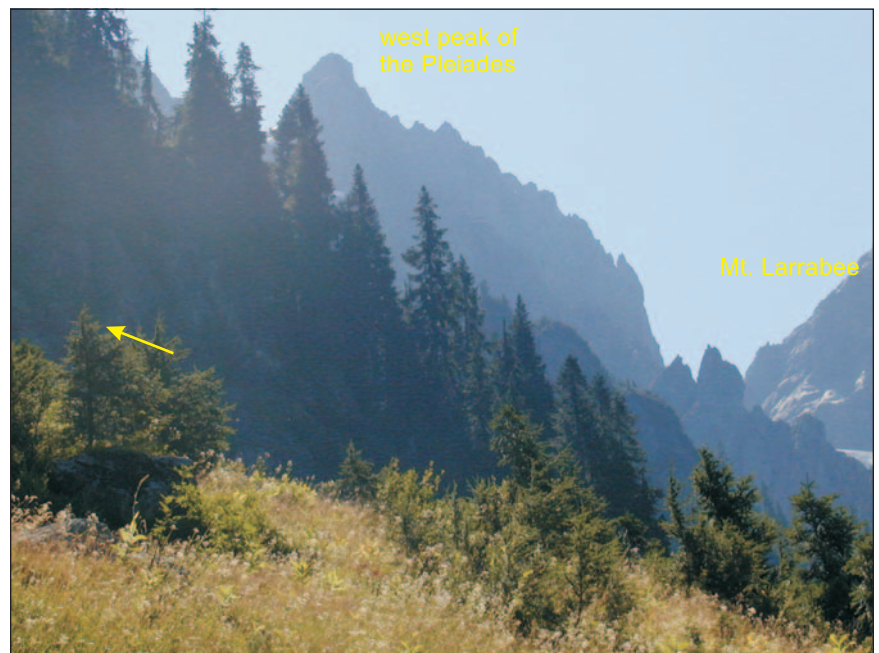
Figure 5. View to the southwest from the 500 Level landing. Arrow points to a trail leading to 100 and 200 Level portals.

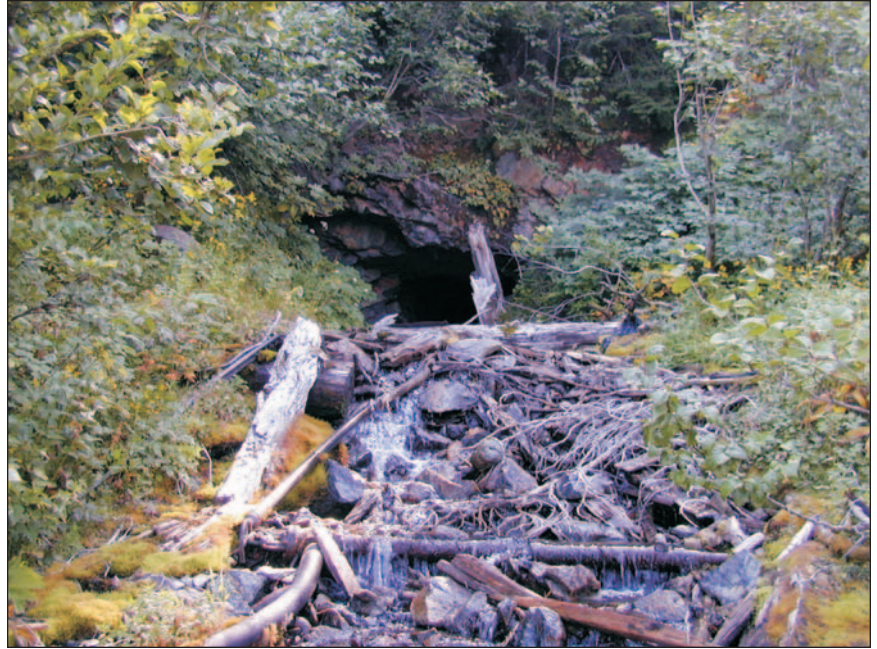
The floor of the 1200 Level is essentially a streambed 6 to 8 inches deep. The portal is open, but the overall internal condition is unknown (Fig. 6). Grant reported it open to the face in 1987. The vertical extent of the mined area from stopes in the 100 Level to the 1200 Level haulage tunnel is approximately 950 feet (Moen, 1969).

Water discharged from the 1200 Level portal in September of 2002 at 500 gallons/minute. The pH measured 8.5 and conductivity reading was 90 μ S/cm. Analyses for arsenic and copper were below the Washington State requirements shown in Table 5 for domestic consumption (WAC 246-290). At a measured hardness of 43 mg/L, the copper content exceeds the calculated standard for chronic effects on aquatic life specified in Table 5 (WAC 173-201A). The water was clear; the bed natural color. Water temperature was 39°F.

Figure 6. Water discharging from 1200 Level portal. Miscellaneous piping and mill equipment in foreground. View to the south.

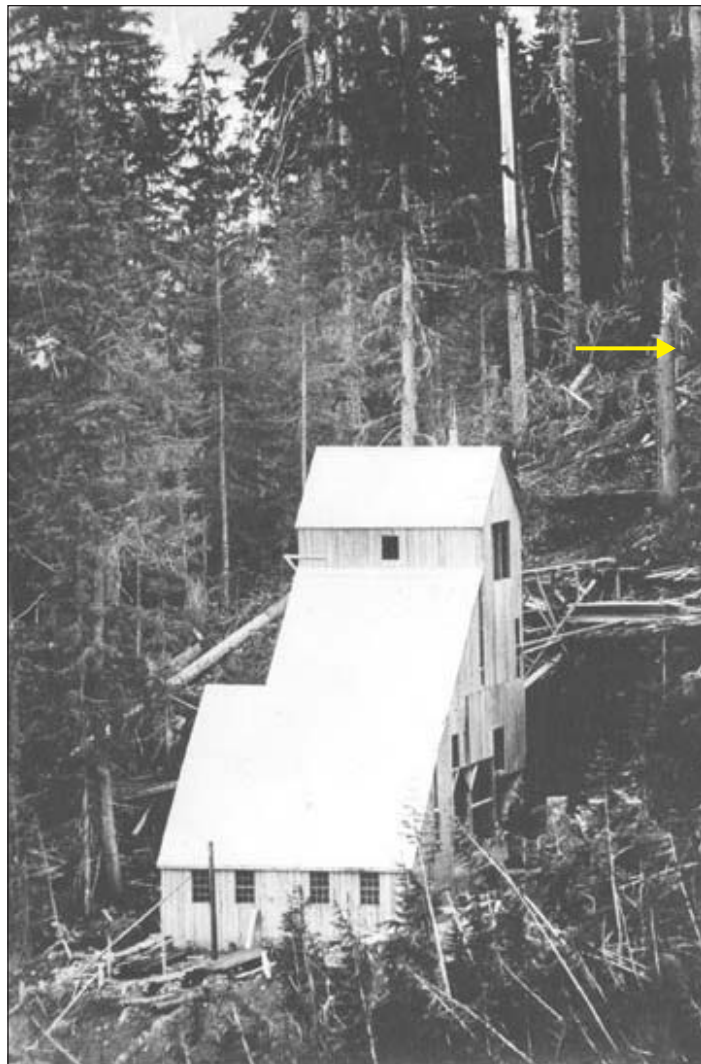
In 1913, a five-stamp mill was constructed at 4000 feet elevation near the company's offices and crew quarters. The mill was supplied with power from a 75 KVA Hendy-Francis generator on Silesia Creek via a 1.5-mile-long transmission line. Ore orig-

Figure 7. Stamp mill circa 1914. The future 1200 Level (1926) is located above and to the right of center (arrow shows approximate location). Courtesy of the Galen Biery Collection #1264, Center for Pacific Northwest Studies, Western Washington University, Bellingham, WA 98225.
